An Investigation of Stream Channel Modifications at Unauthorized Suction Dredging Sites on the South Fork Clearwater River, October 7 and 8, 2015

Dan Kenney
North Zone Fisheries Biologist
Nez Perce-Clearwater National Forests
February 3, 2016

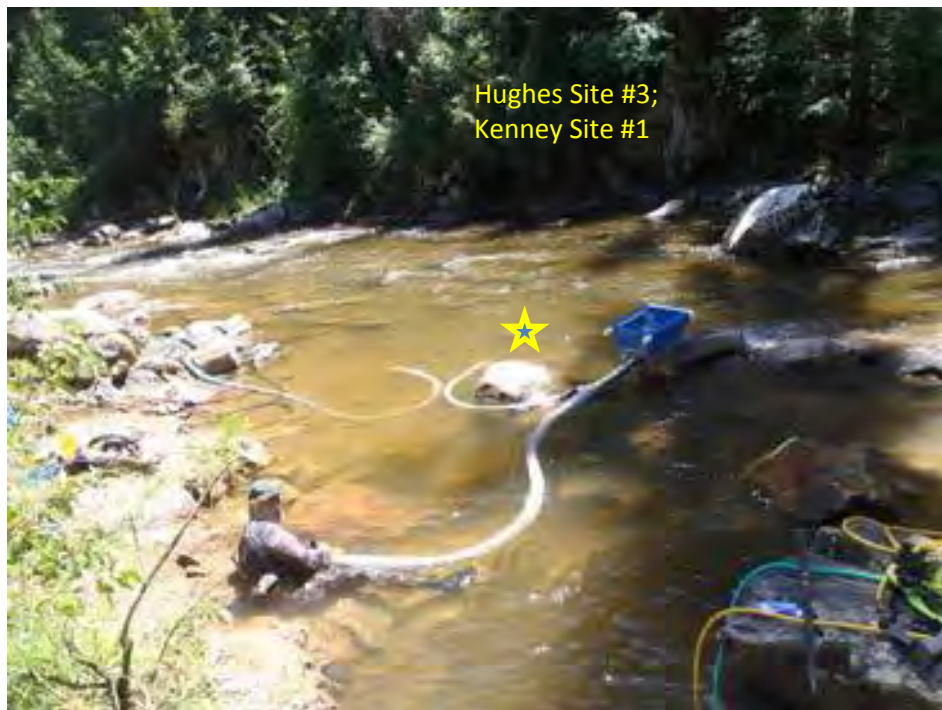
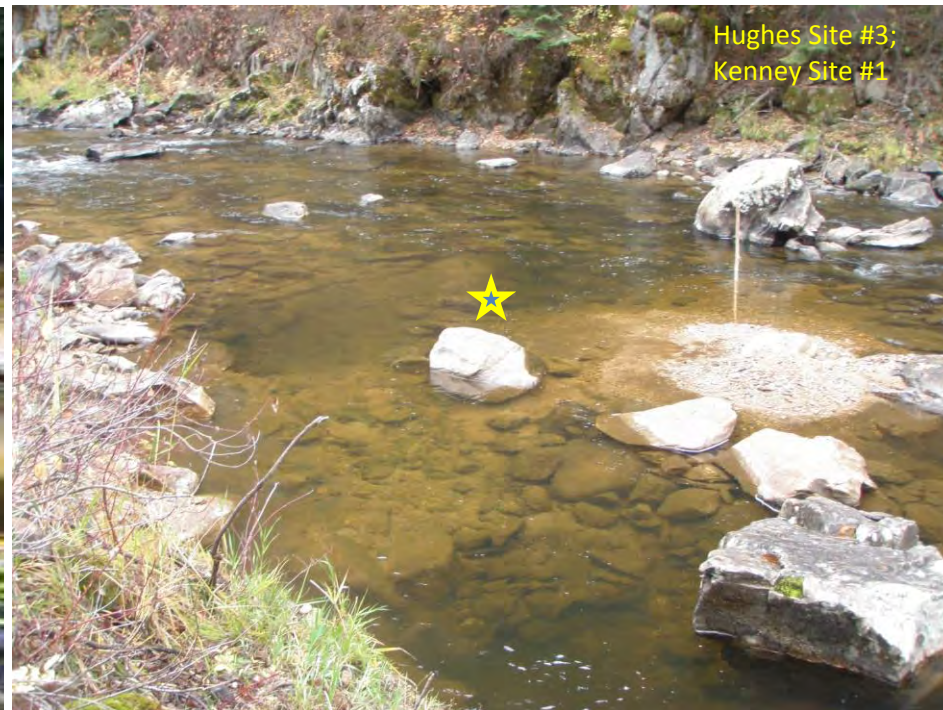
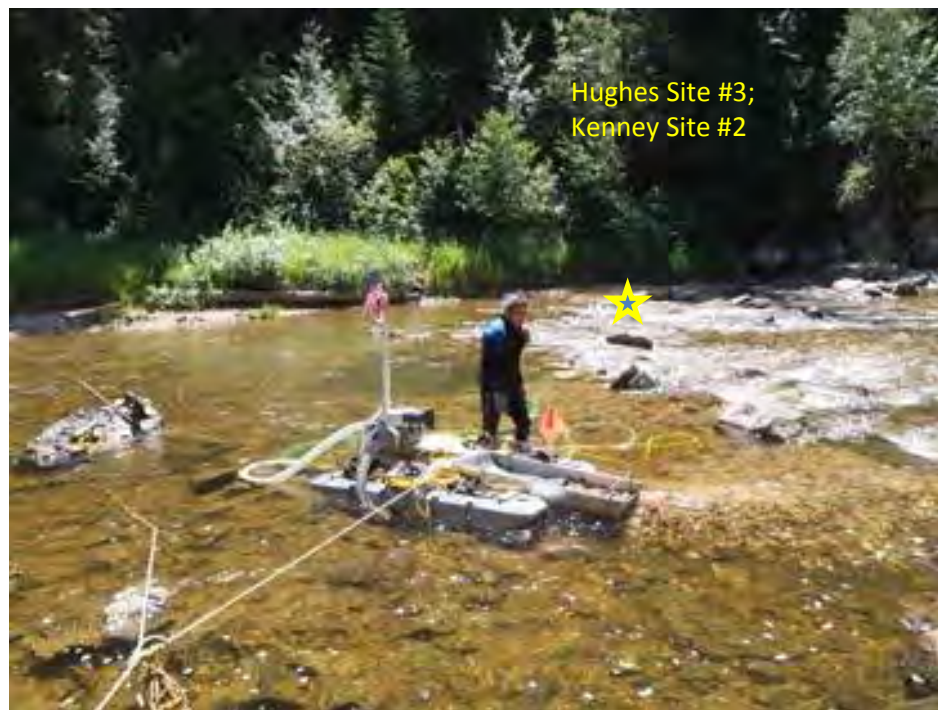
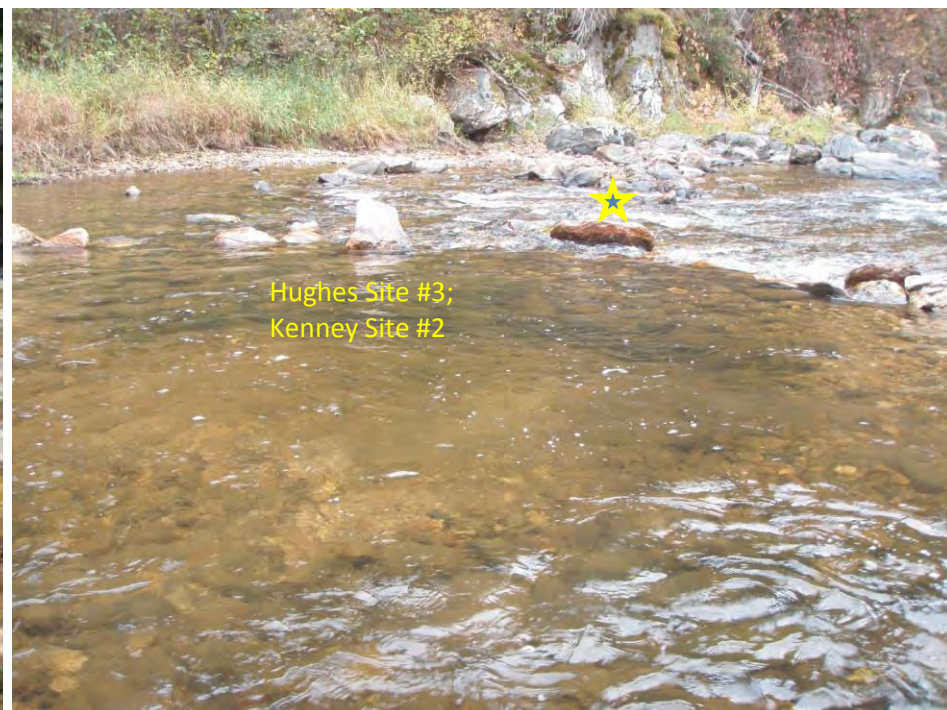
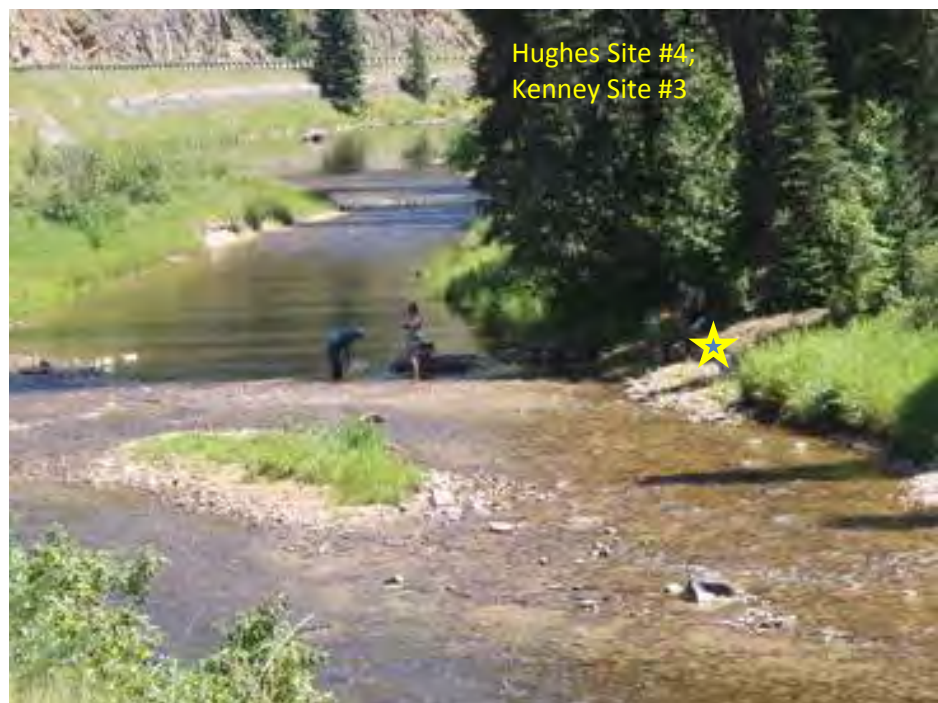
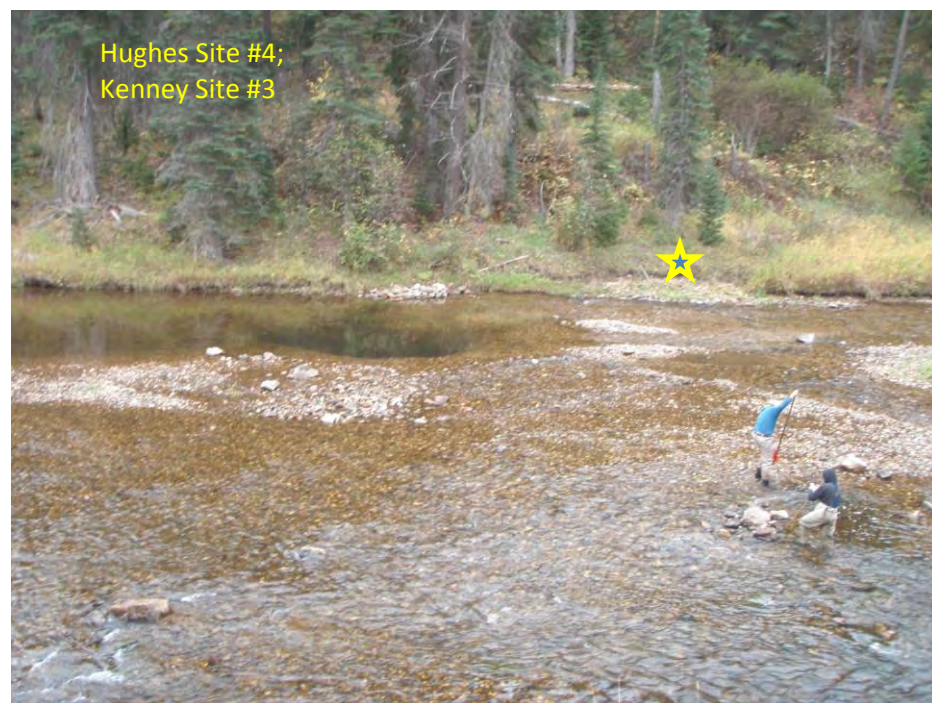
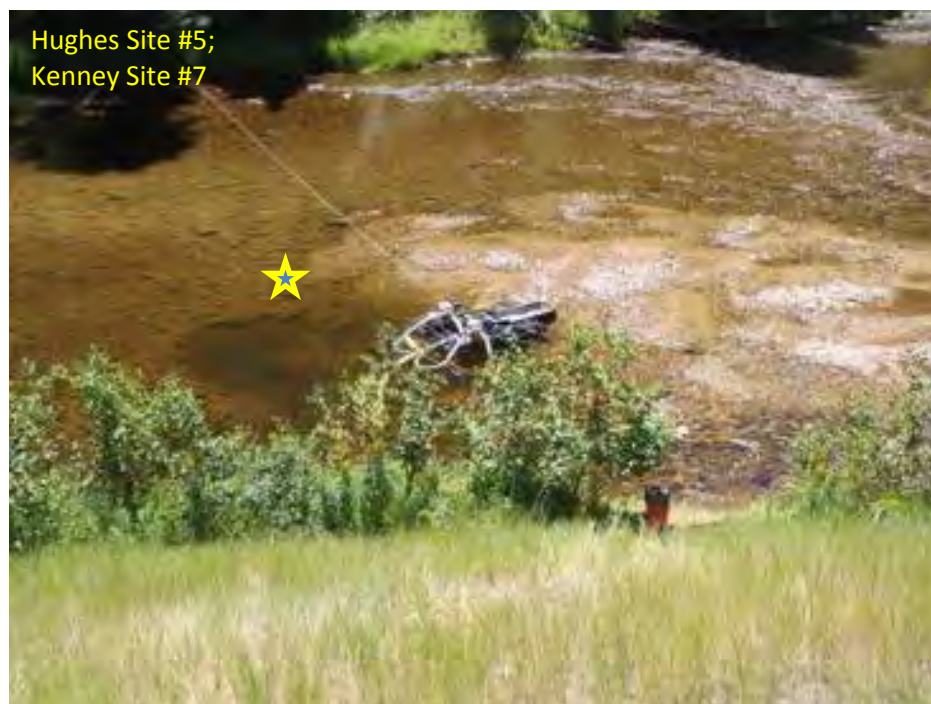
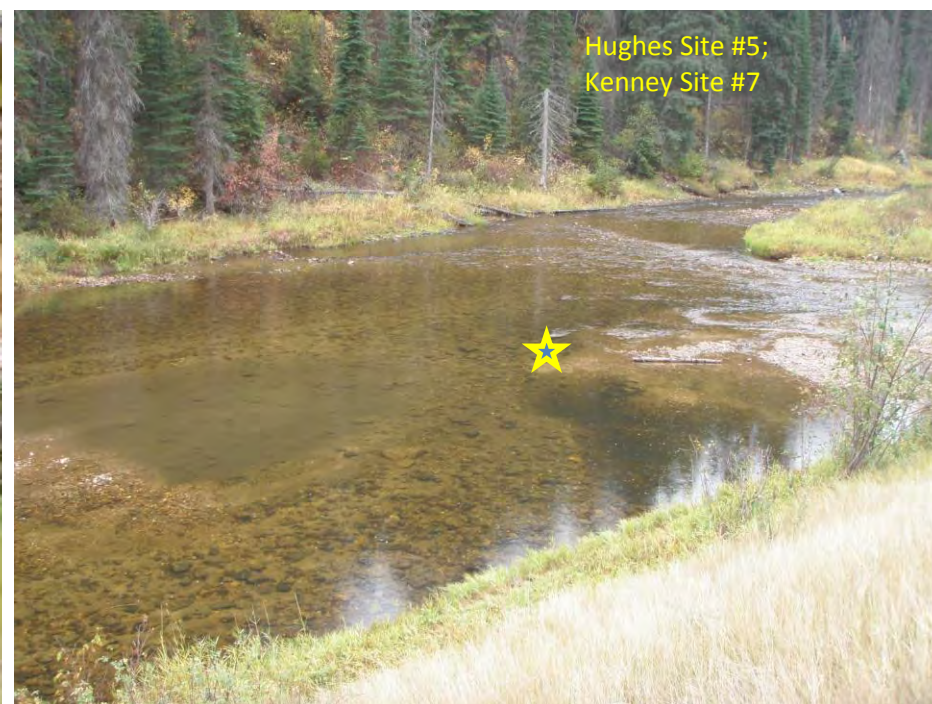
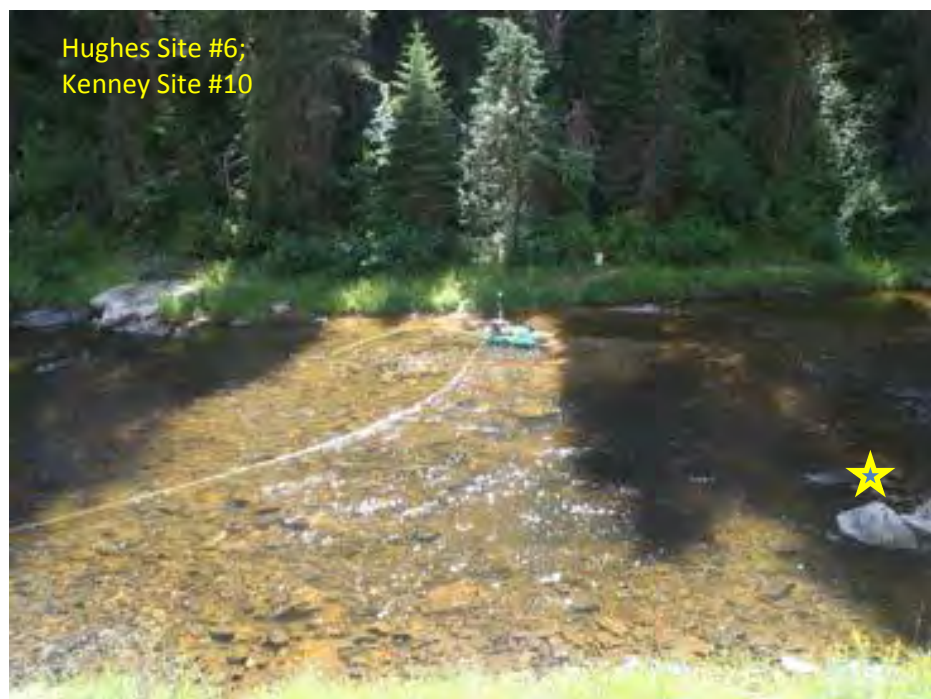
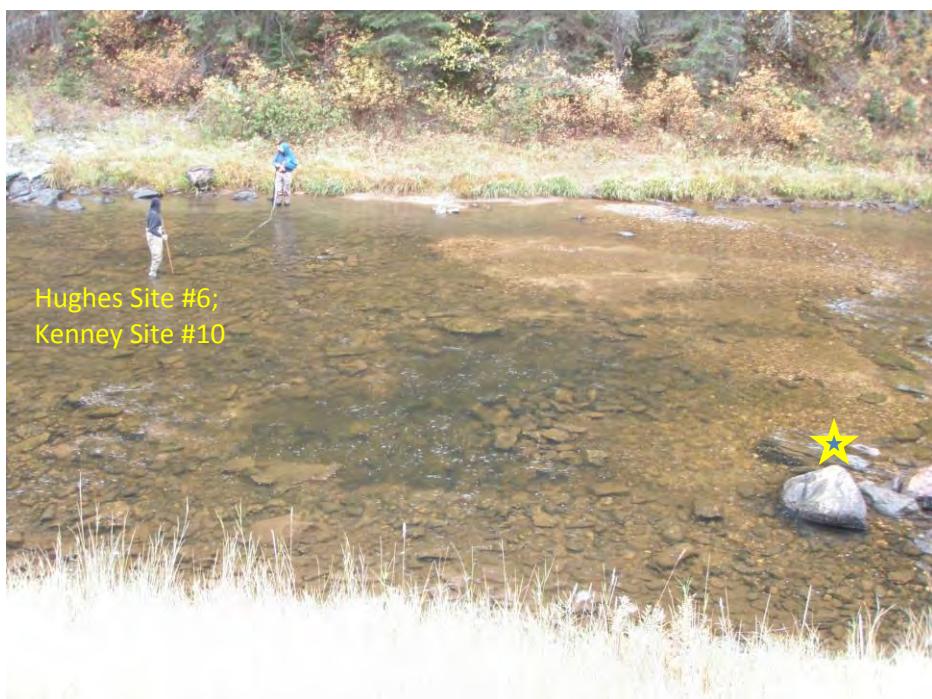
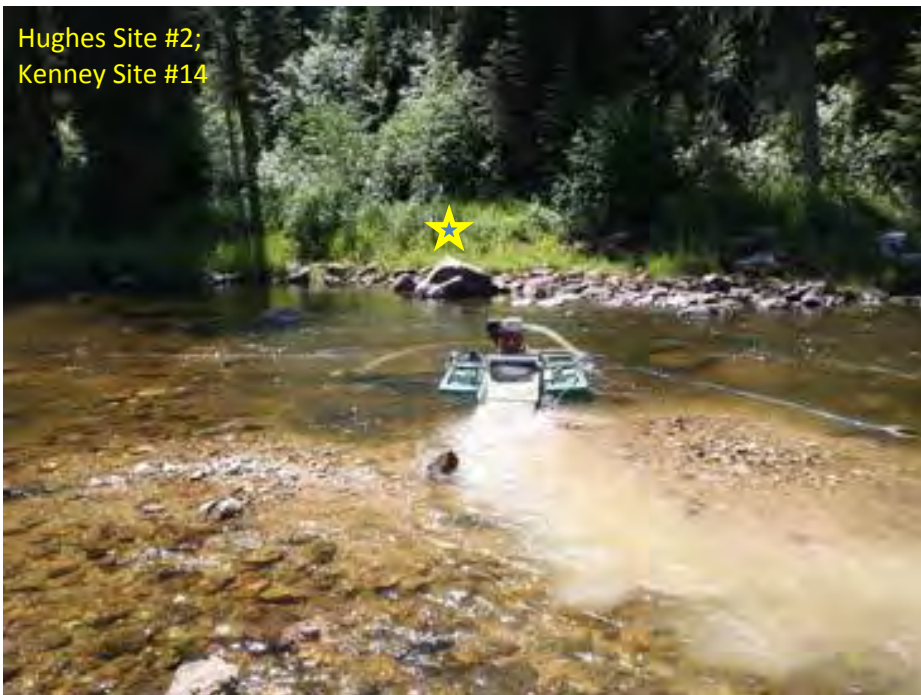
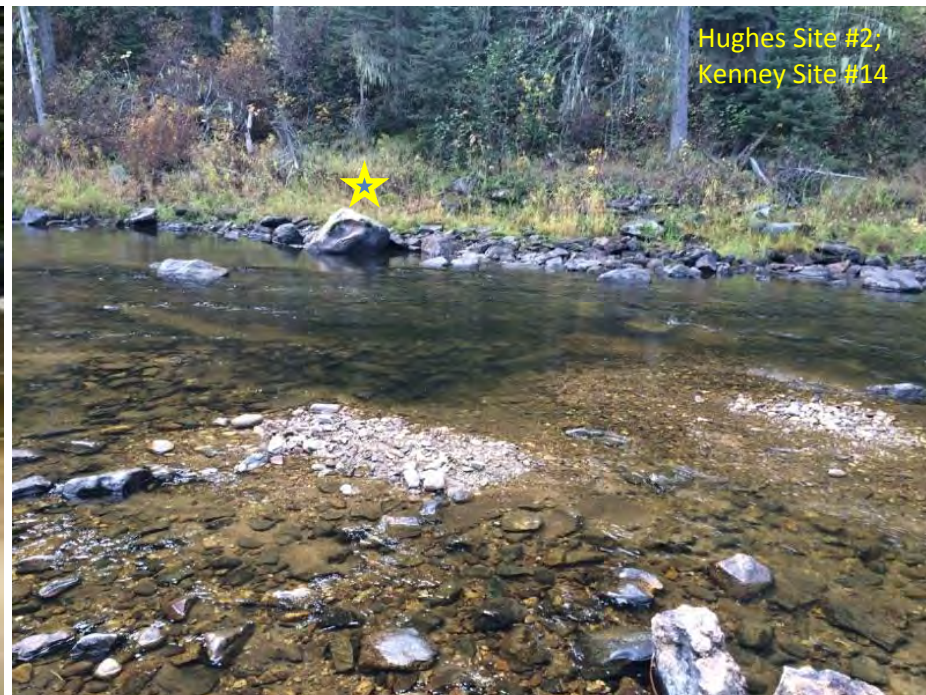
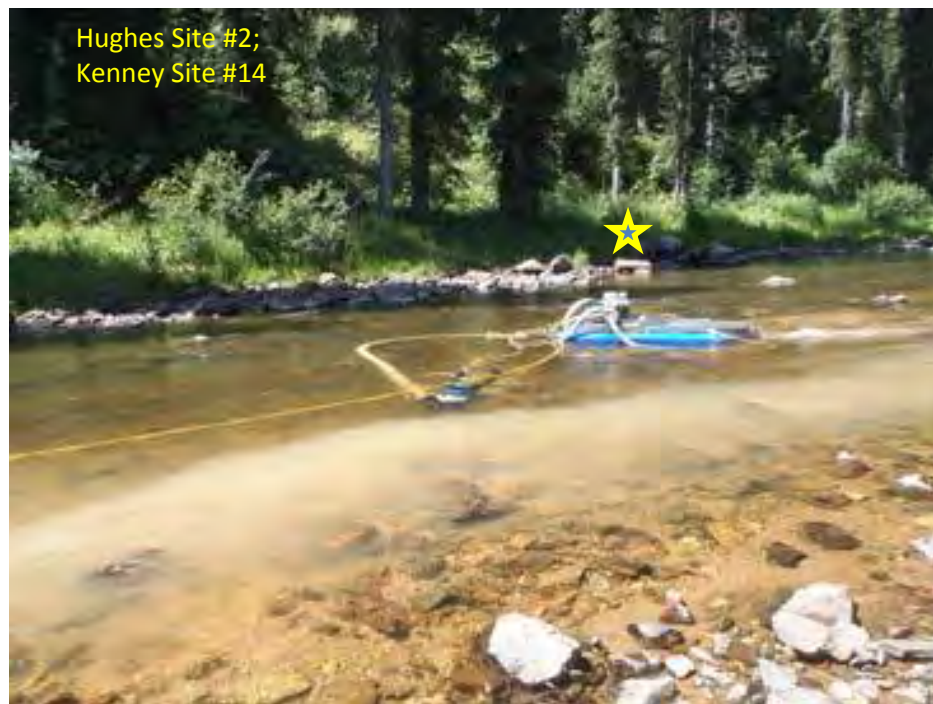
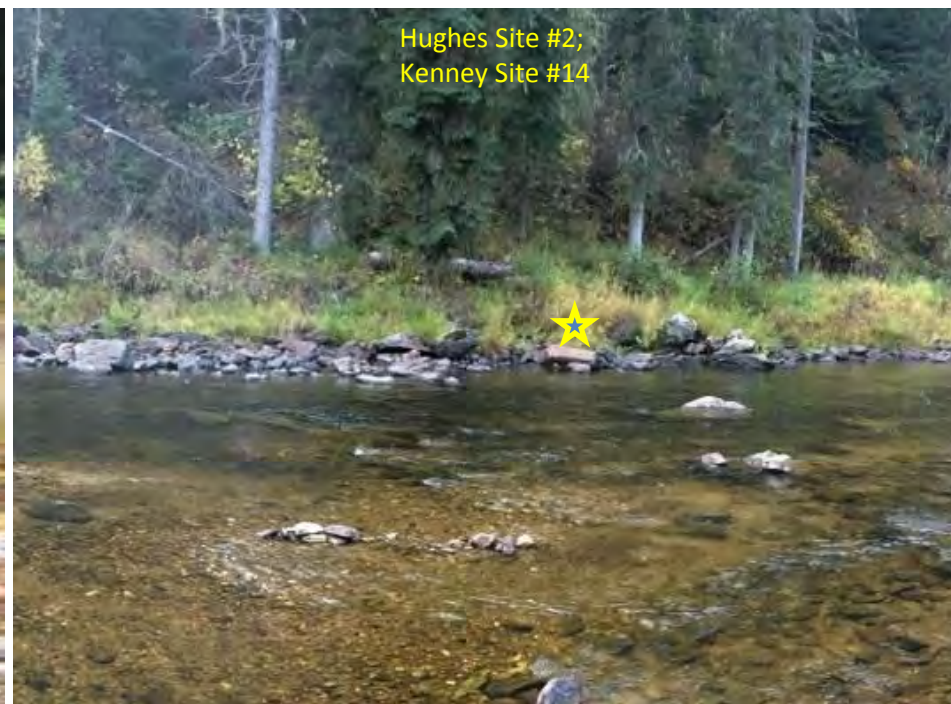
Appendix B.

Appendix B compares photos from dredging sites in July 2015 with those associated with this report. These photos demonstrate that additional dredge mining was performed at some of the sites between July and October, but also that existing holes and tailings piles were easily recognizable after a 2½-month low-flow period. The tailings piles, in particular, stood out visually because the relative lack of periphyton growth on the dredged and relocated substrate contrasted with the darker, relatively undisturbed surrounding substrate.

Comparison of 7 selected pairs of photos from Hughes (2015) July inspection with Kenney (this document) October inspection.

Photos are paired side by side, with July photo on left, and October photo on right.
